### REHABILITATION OF EXISTING WSHALLOW WELL

Project:	Active Project
Site'sName:	Rehabilitation of a Shallow well at Bosaso
Drawing's Title:	Rehabilitation of existing w Shallow well
Drawing's Number:	01

Project:	Active Project
Site's Name:	Rehabilitation of a w Shallow well at Bosaso
Drawing's Title:	Metallic Fence & Gate Typical Installation
Drawing's Number:	02

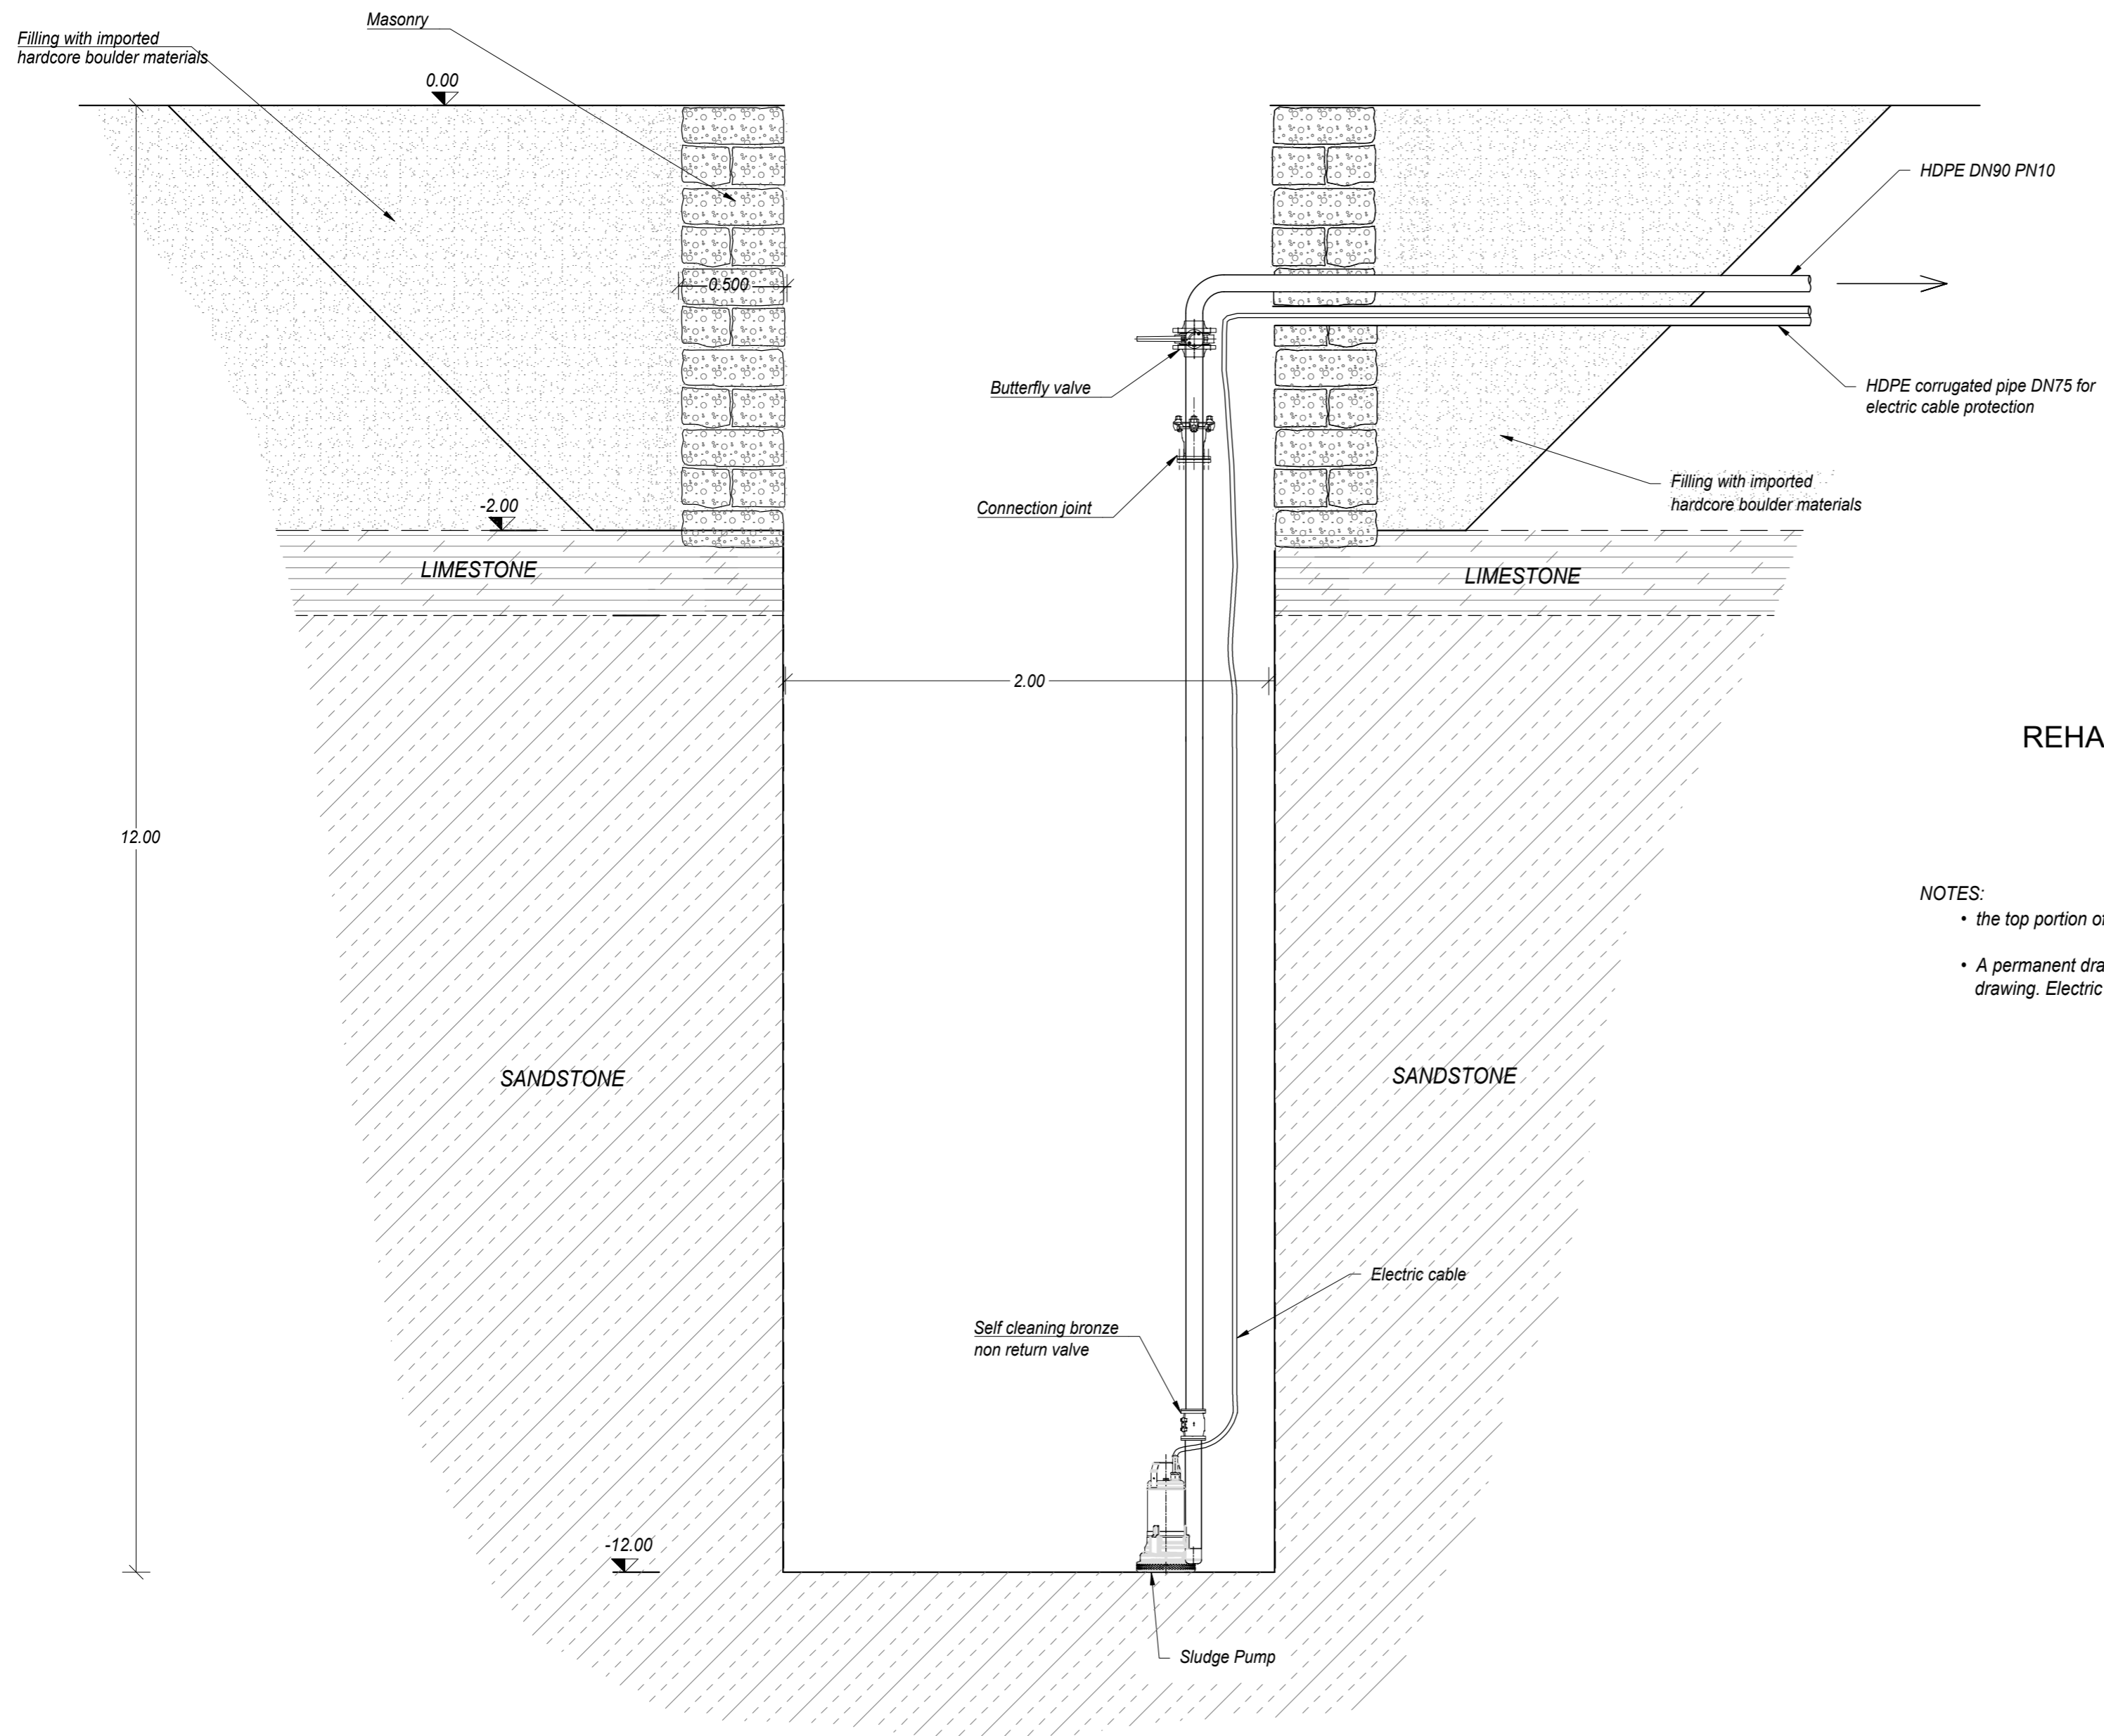
- the top portion of the well must be protected by mansory and refilling with imported hardcore boulder materials
- A permanent drainage pump must be properly installed and the delivery pipe connected with the water tank as specified in the drawing. Electric cable must be installed inside HDPE corrugated pipe DN 3"
