Project:	Active Project
Site'sName:	Rehabilitation of a well at Midigale site
Drawing's Title:	Rehabilitation of existing w Shallow well
Drawing's Number:	01

Project:	Active Project
Site's Name:	Rehabilitation of a well at Midigale Site
Drawing's Title:	Shoats & Camel Water Trough Plan and Section
Drawing's Number:	02

Project:	Active Project
Site's Name:	Rehabilitation of a well at Midigale Site
Drawing's Title:	Power System
Drawing's Number:	03

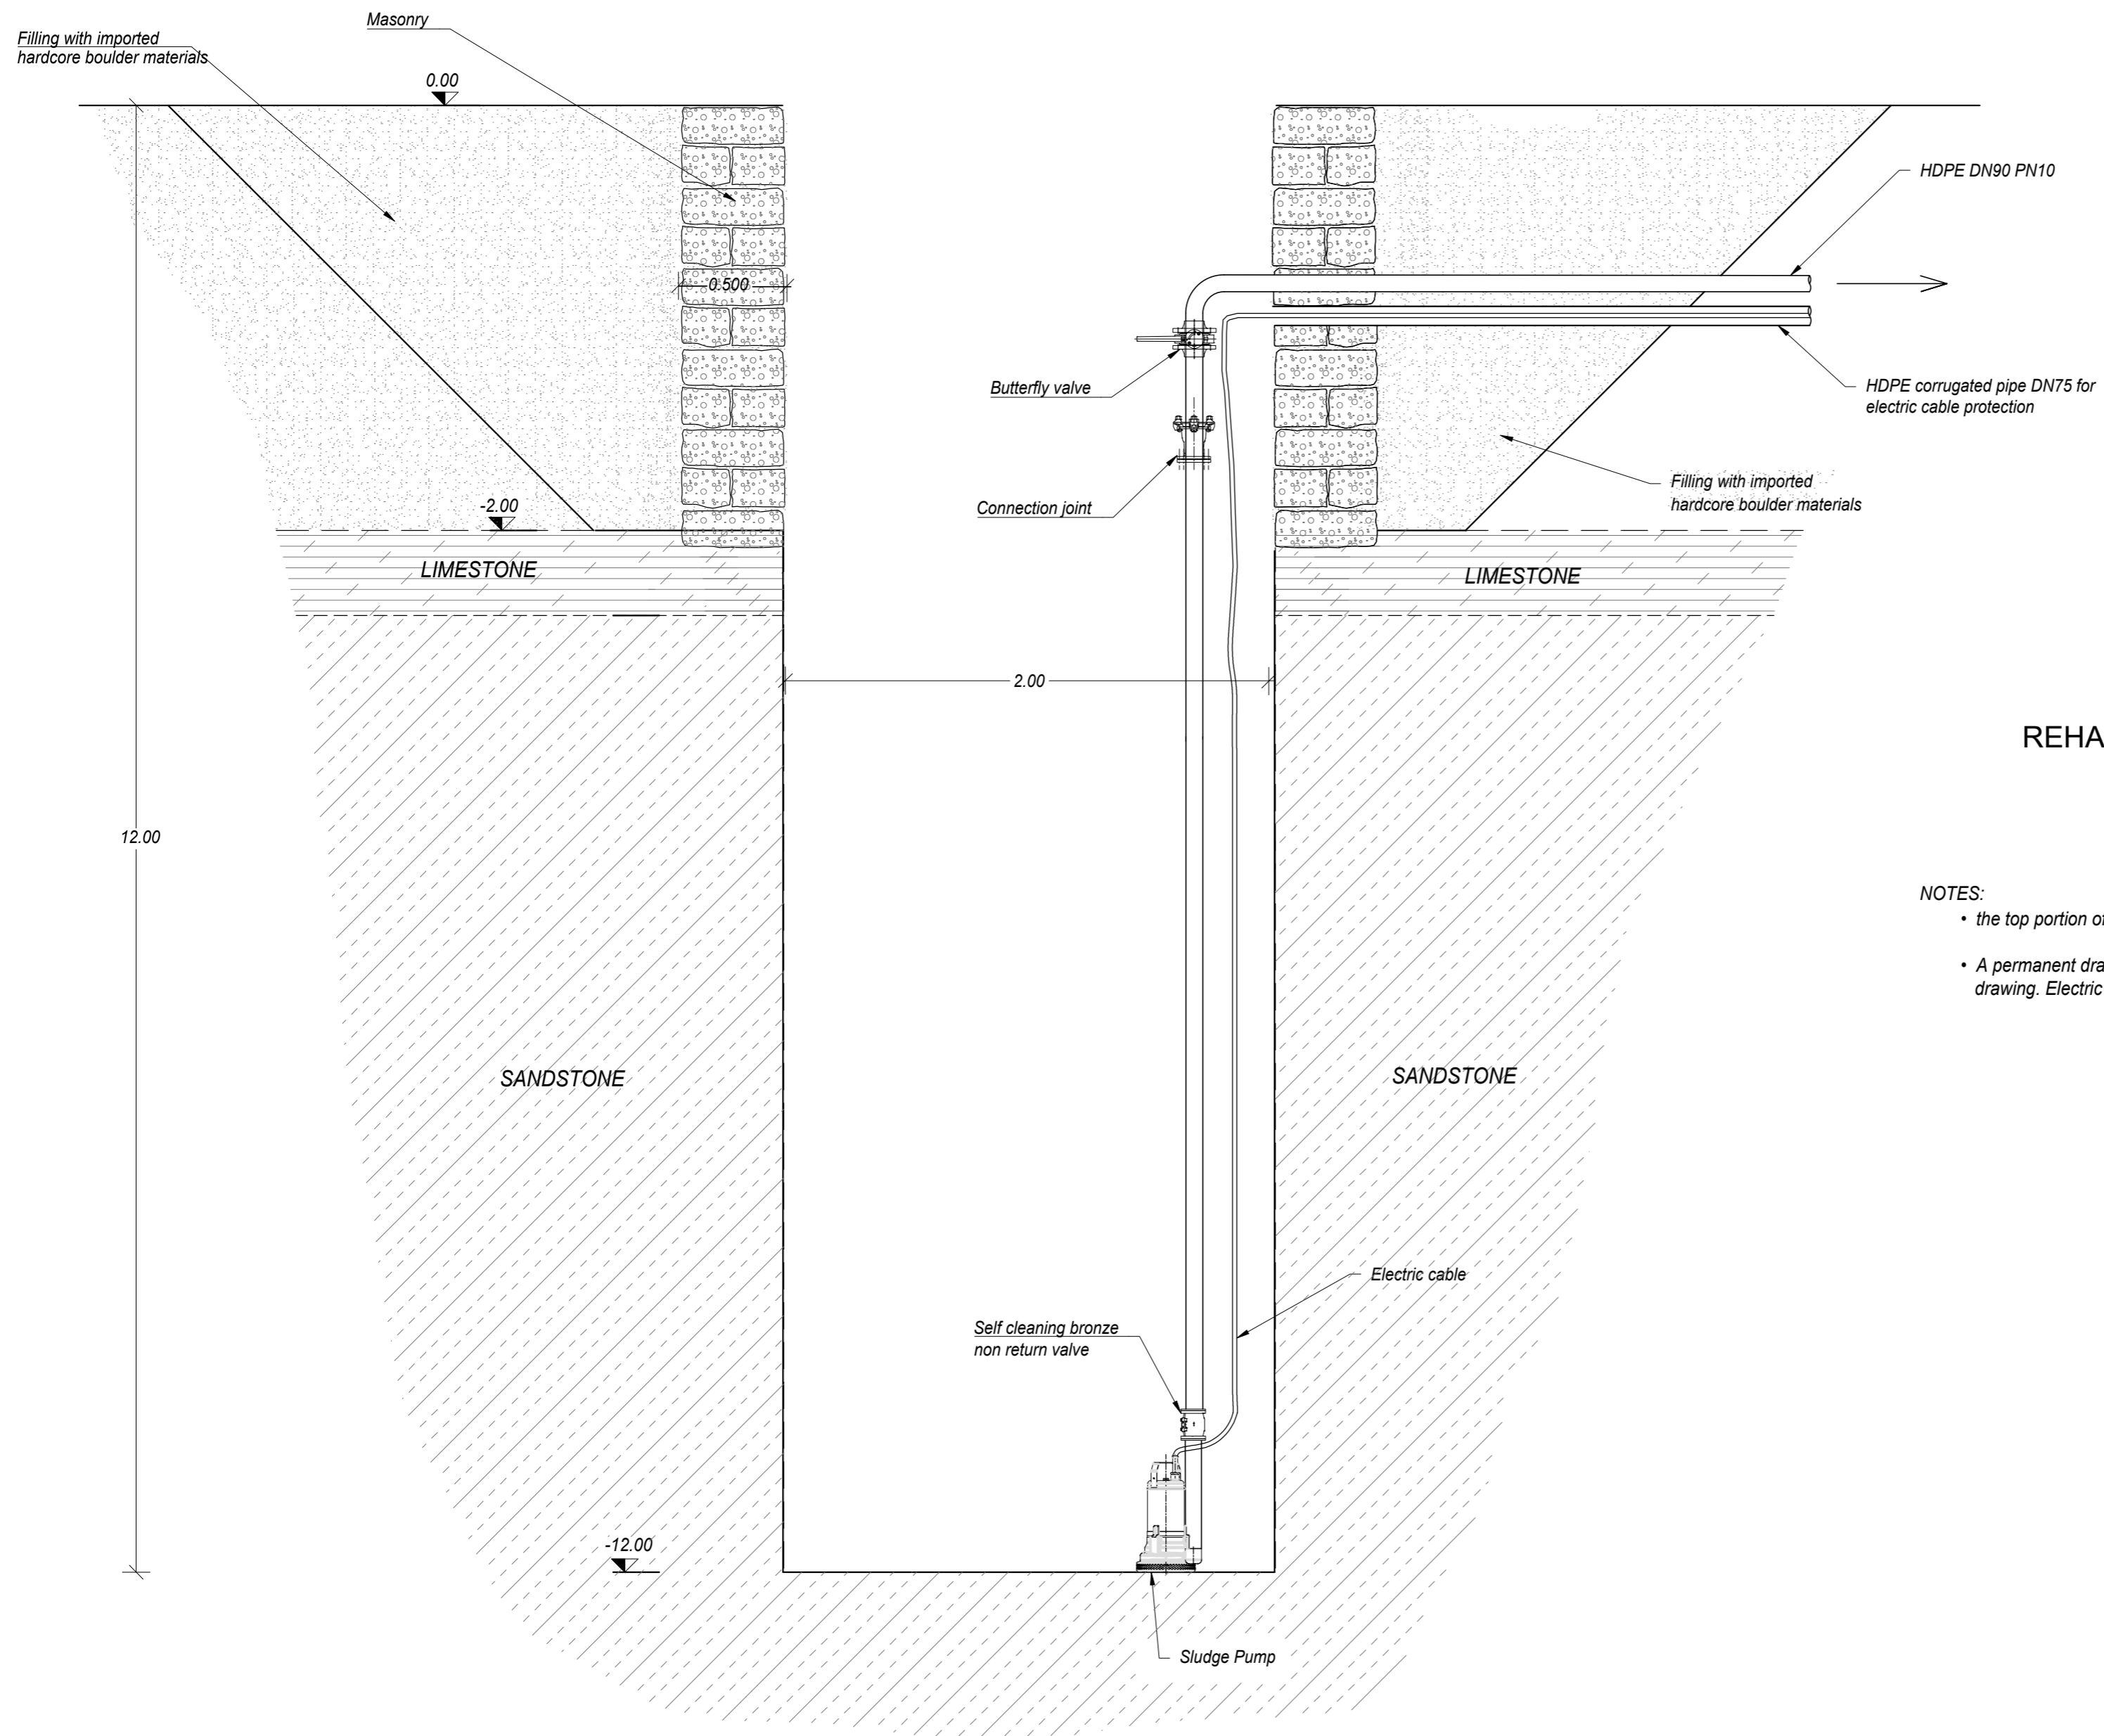
### REHABILITATION OF EXISTING WSHALLOW WELL

- the top portion of the well must be protected by mansory and refilling with imported hardcore boulder materials
- A permanent drainage pump must be properly installed and the delivery pipe connected with the water tank as specified in the drawing. Electric cable must be installed inside HDPE corrugated pipe DN 3"

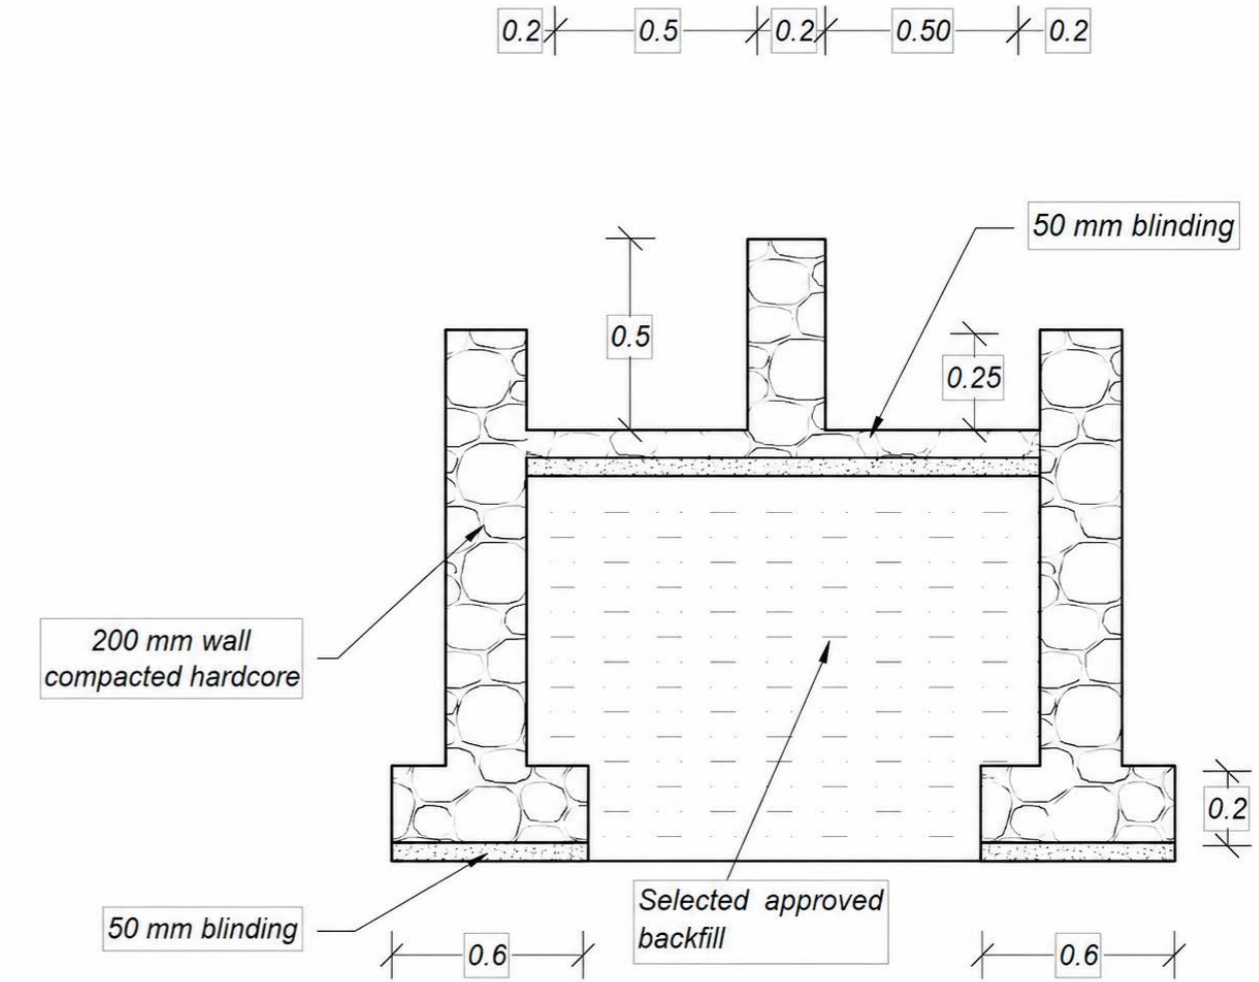
### SHOATS TROUGH SECTION

Scale: 1:25

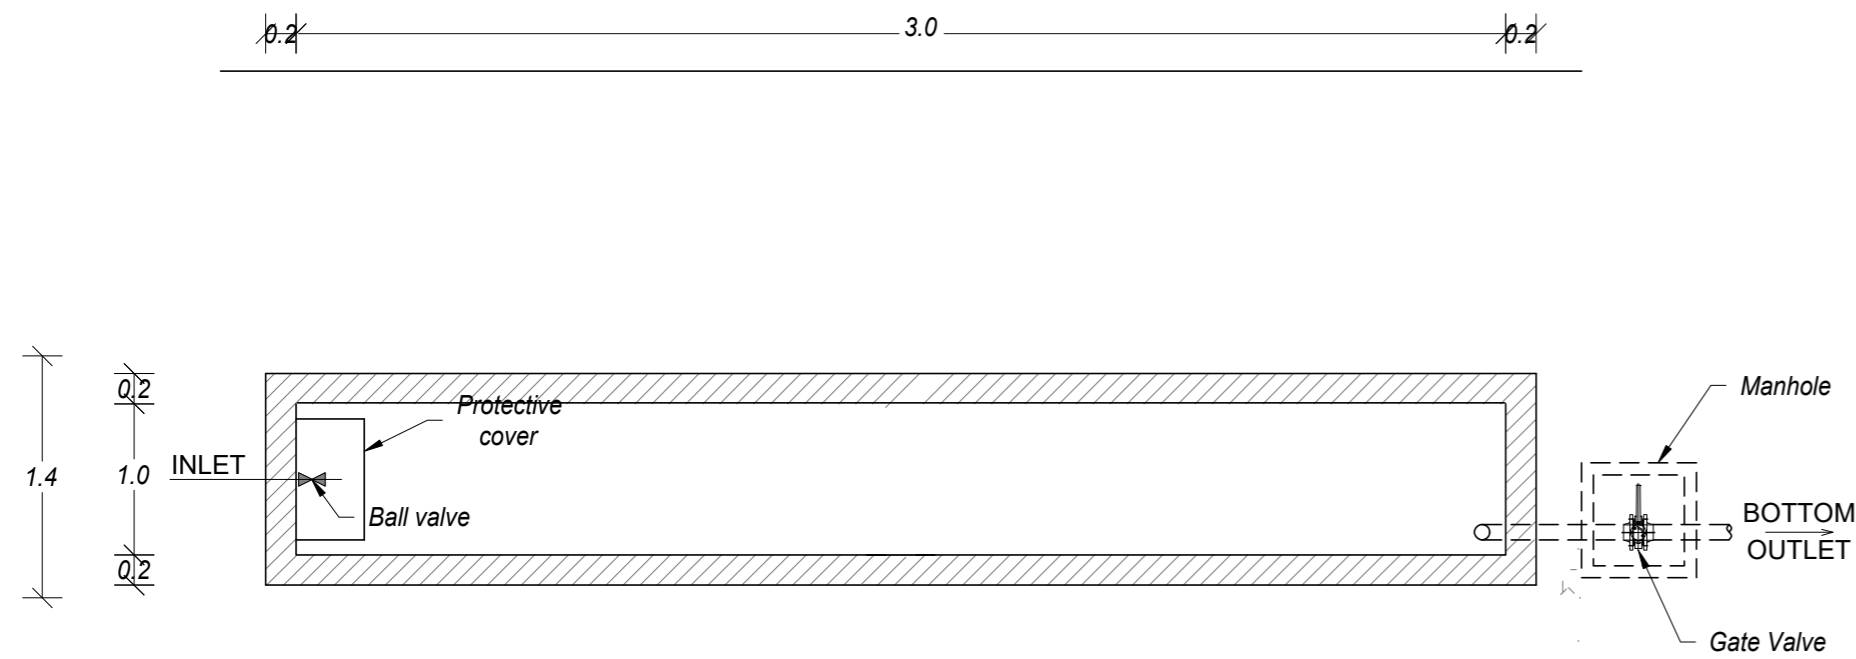
### CAMEL WATER TROUGH PLAN

Scale: 1:50

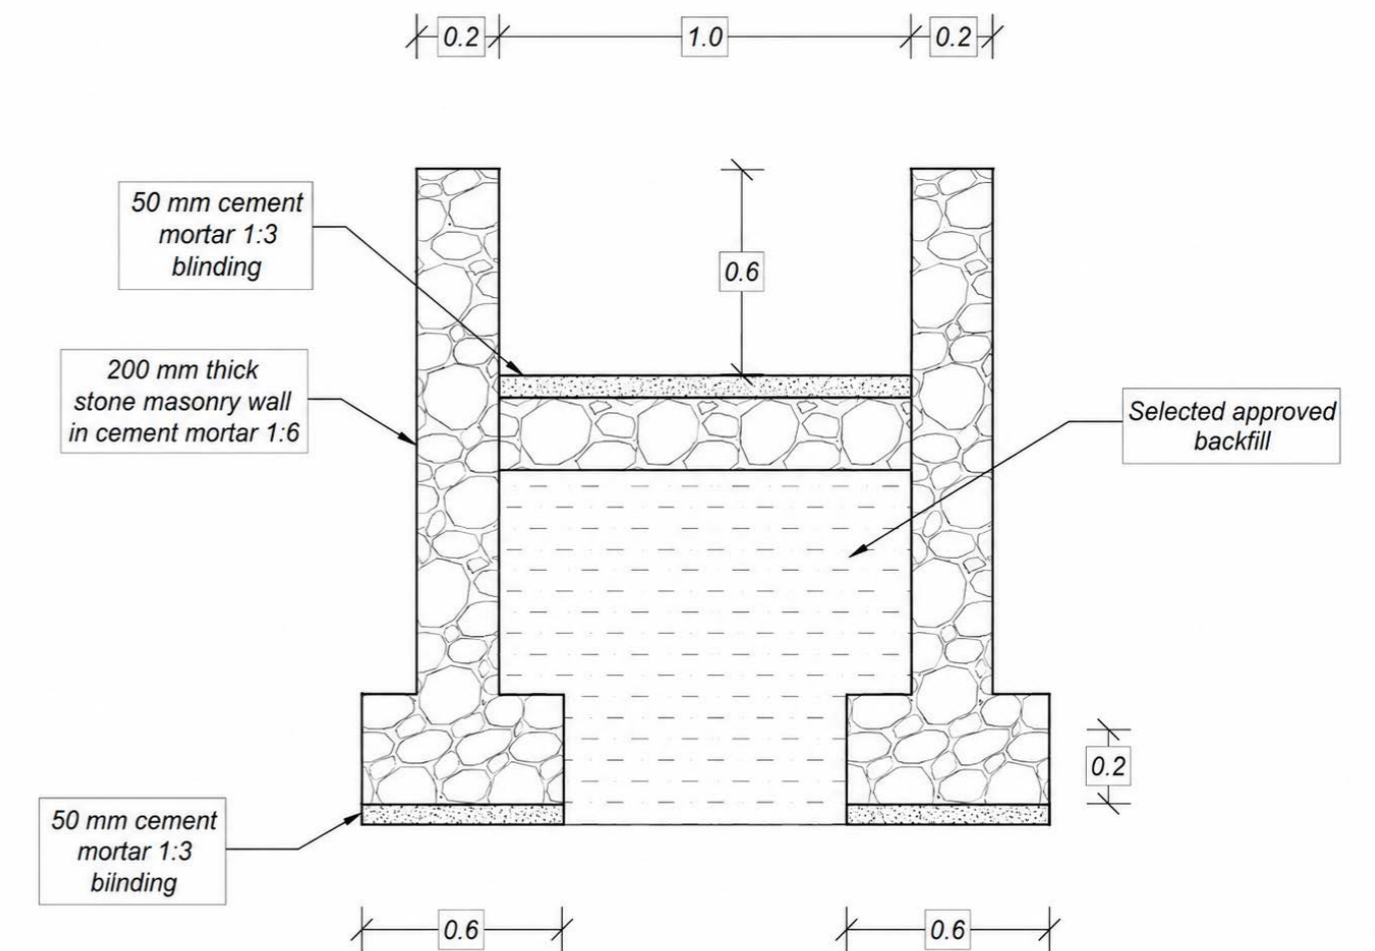
### CAMEL TROUGH SECTION

Scale: 1:25
